Pacific Gas and Electric Company

Tree Root Interference Assessment

January 17, 2014

Dynamic Risk Assessment Systems, Inc.

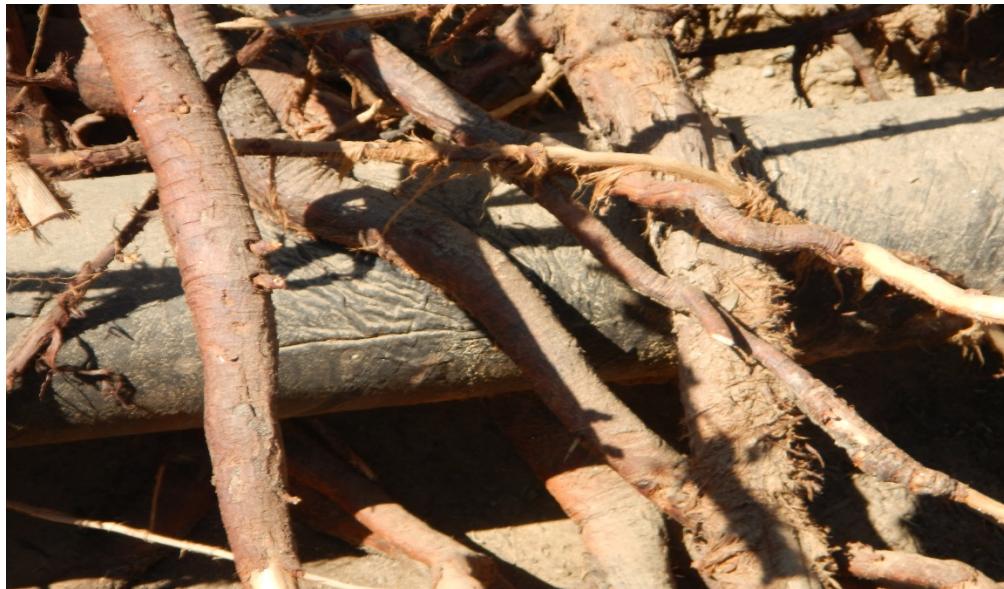
**Figure 3. RWVIM-107-13 (Weber Lane)
(CTE coating damage)**

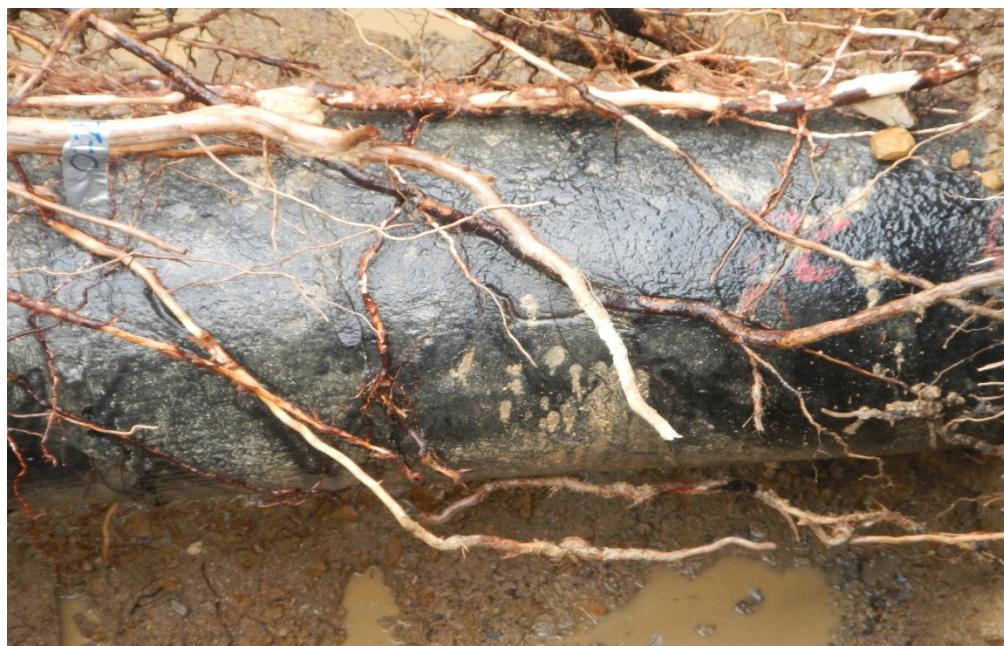
**Figure 4. RWVIM-74-13 (Atascadero)
(Tape coating damage)**

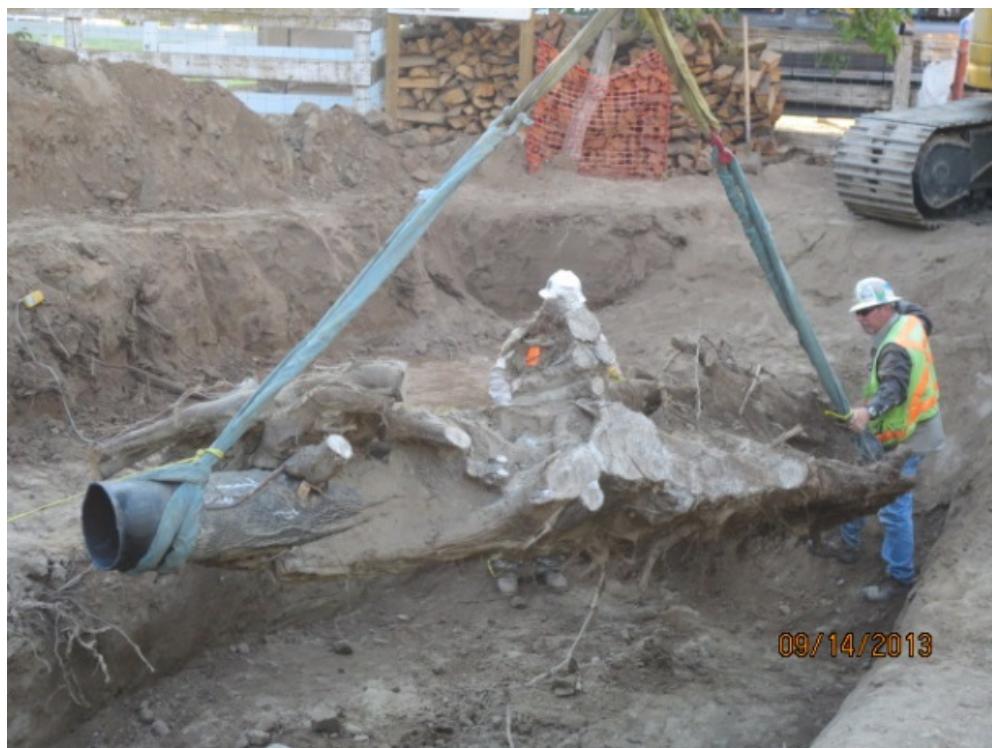
Figure 6. RWVIM-90-13 (Hall Road)

Tree root and pipeline interactive conditions were reviewed relative to the potential for pipeline structural damage. An example of one location where the tree root ball was situated directly on top of the pipe and the tree roots encapsulated the buried pipe is presented in Figure 6 (RWVIM-90-13, Hall Road).

The Hall Road site provides evidence of what can occur when a tree root ball and root system is located in close proximity to a buried pipeline. A primary concern under these conditions is that weather (e.g., high force winds, flooding, seismic events) may cause tree and root movement, resulting in pipe damage. In addition, since the buried pipeline and tree root systems are interconnected, a lightning strike to the tree would most likely also impact the pipeline and provide an electrical path for the strike and may also provide a path for the electrical discharge.
