# Lafayette, CA Pipeline Tree Review

**Pacific Gas and Electric**

CN Utility Consulting, Inc.  
5930 Grand Ave  
West Des Moines, IA 50266

**September 14, 2023**

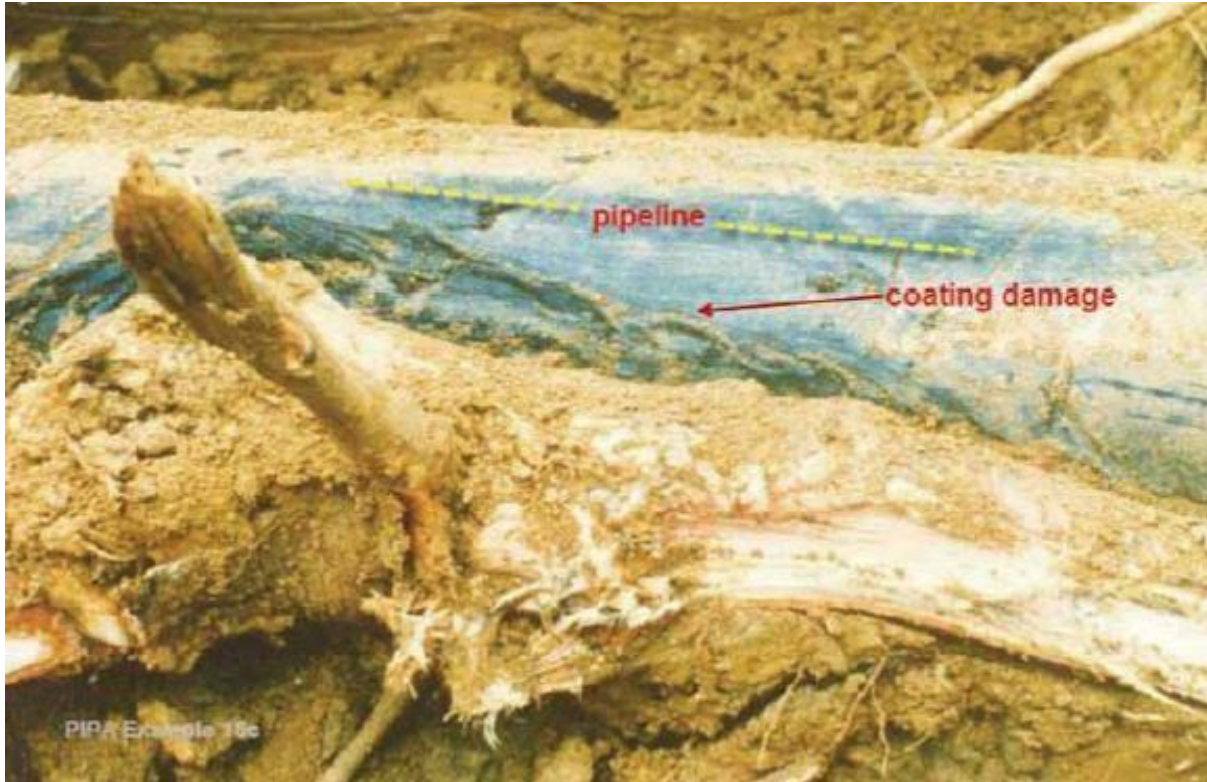
The investigators found that indirect damage is common, as tree roots grew to compromise pipe coating, potentially exposing the pipe to corrosion (Figure 1). They note that smaller roots can cause this type of damage 100 or more feet from the tree trunk (Randall Frizzell and Associates, 2012). They further observed that in rare cases, large roots contacting a pipeline can exert enough force to damage pipelines when the root flexes as the tree responds to or is toppled by high wind or an earthquake. These later conclusions are corroborated by Mattheck et al. (*The Body Language of Trees*, 2015) who determined that hydrotropic growth can direct roots to pipes. They note that roots are attracted to the top of pipes on the predominately leeward side of prevailing winds and under it on the windward side. This windward growth leverages the pipe as an anchor. So as wind blows, tree roots that have grown in proximity to pipes on the predominately leeward side impose compression forces on the pipe, while those on the windward side have the potential to lift it. Mattheck argues that both forces could damage pipelines. Finally, Appendix C of the Pipeline & Hazardous Material Safety Administration's report *Partnering to Further Enhance Pipeline Safety in Communities Through Risk-informed Land Use Planning* (PIPA, 2010) devotes space to describing why trees are incompatible with pipelines, and provide examples, such as the photo in Figure 1, to substantiate this argument.

**Figure 1.** A root growing along a buried pipeline that has damaged the coating (Figure 11 from Randall Frizzell & Associates 2012--photo from PIPA 2010).

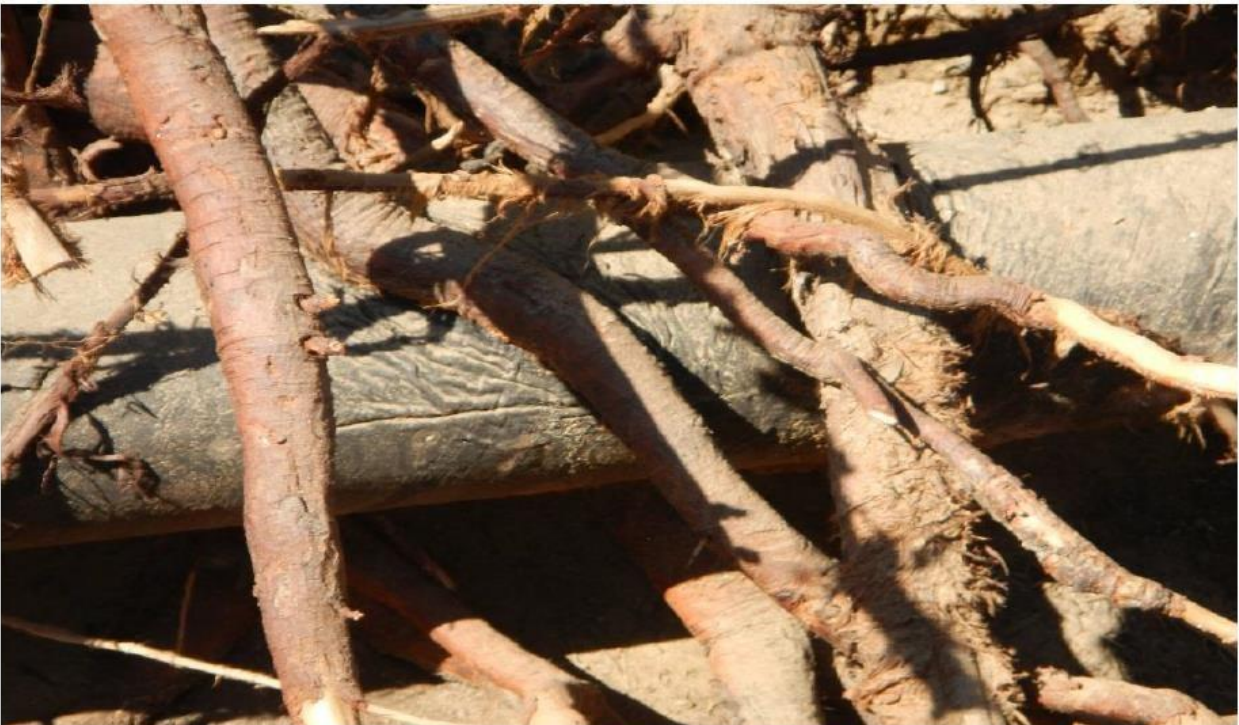
**Figure 2.** Tree roots causing coating damage to RWVIM-107-13 (Weber Lane) pipeline. (Figure 3 from Dynamic Risk 2015).
