Pacific Gas and Electric Company

Tree Root Interference Assessment

January 17, 2014

Dynamic Risk Assessment Systems, Inc.

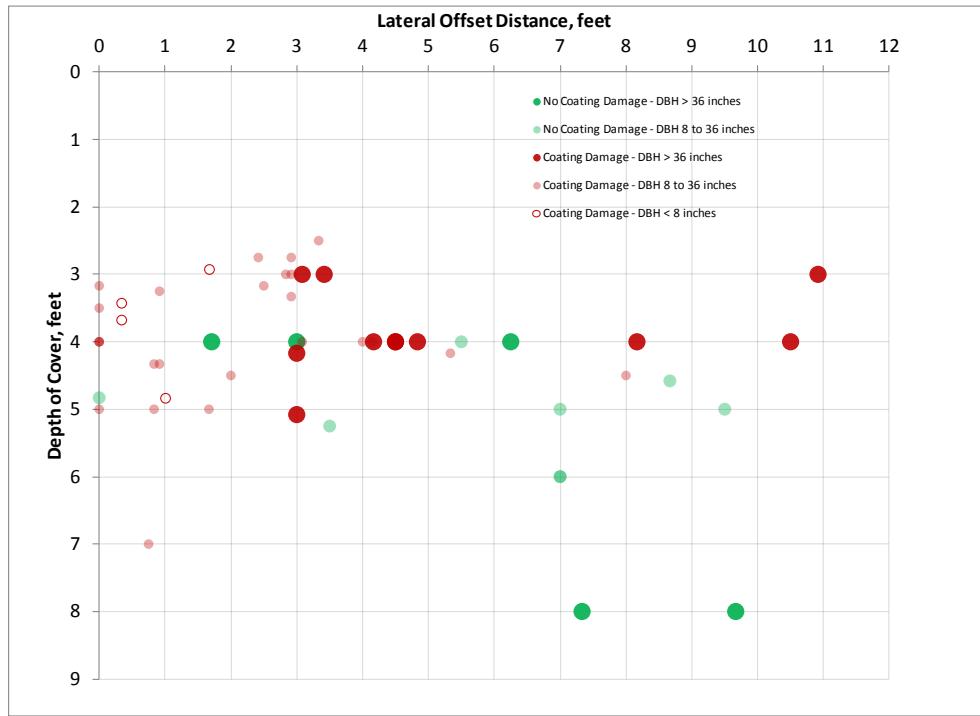
Figure 5. Depth of Cover versus Lateral Offset Distance^s.

In evaluating the results from the 53 sites, a comparison between the lateral offset distance and depth of cover was produced and is presented in Figure 5. The legend provided in this figure discriminates the data based upon the tree diameter (DBH) and whether or not coating damage was evident.

As is evident from Figure 5, there is no obvious trend from these results. This is likely due to the number of attributes that influence the results. However, it is evident that tree size (DBH), offset distance, and depth of cover may be indicators as to whether or not coating damage has occurred.
