# Lafayette, CA Pipeline Tree Review

**Pacific Gas and Electric**

CN Utility Consulting, Inc.  
5930 Grand Ave  
West Des Moines, IA 50266

**September 14, 2023**

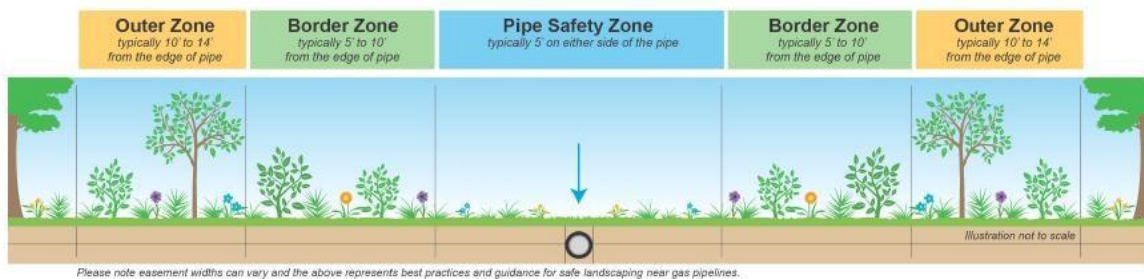
The PG&E pipeline encroachment standard specifies the classic “pipe-border zone” model (Figure 3). The pipe zone is managed as a treeless area to prevent roots from interfering with pipelines, maintain access for maintenance, and identify the pipeline location in the right-of-way. This approach is compatible with accepted vegetation management practices, which advise that the width of the treeless zone should be determined by the operator (Miller, 2021; Miller and Kempter, 2018).

**Figure 3.** PG&E’s pipe safety zone and border zone (Figure 1 from PG&E 2017). The figure depicts the classic pipe zone border zone approach.
